Typhoon Hagibis strikes the Japanese Archipelago: What happened behind the scenes as Japan's capital narrowly escaped becoming submerged

Although Typhoon Hagibis (Typhoon 19) caused enormous damage to many parts of Japan in 2019, Tokyo saw no dikes collapse and escaped serious flood damage. We investigated the truth of what occurred behind the scenes during the Japanese capital's escape from submersion, based on the reports of local government officials and flood control facilities.

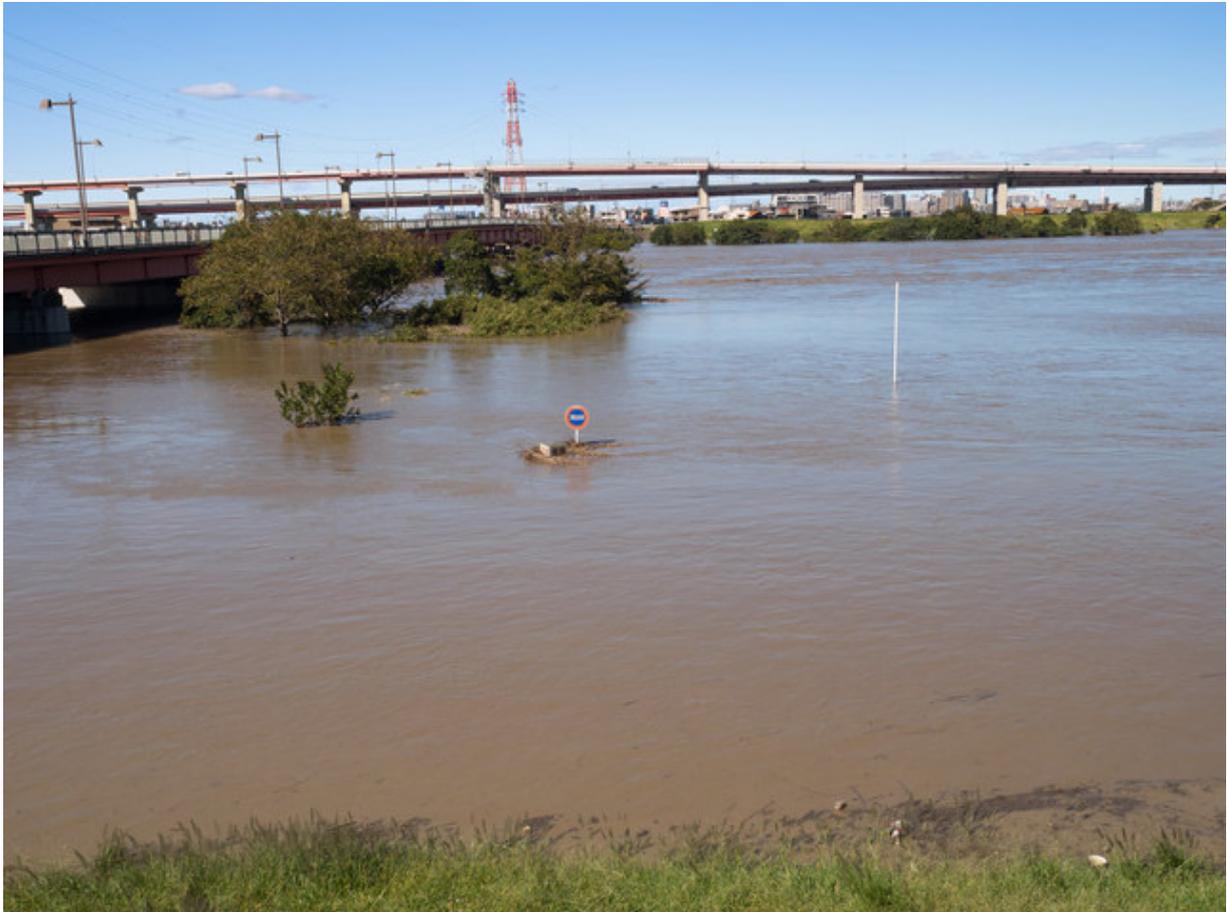
The Arakawa River went above the dangerous water level at multiple points.

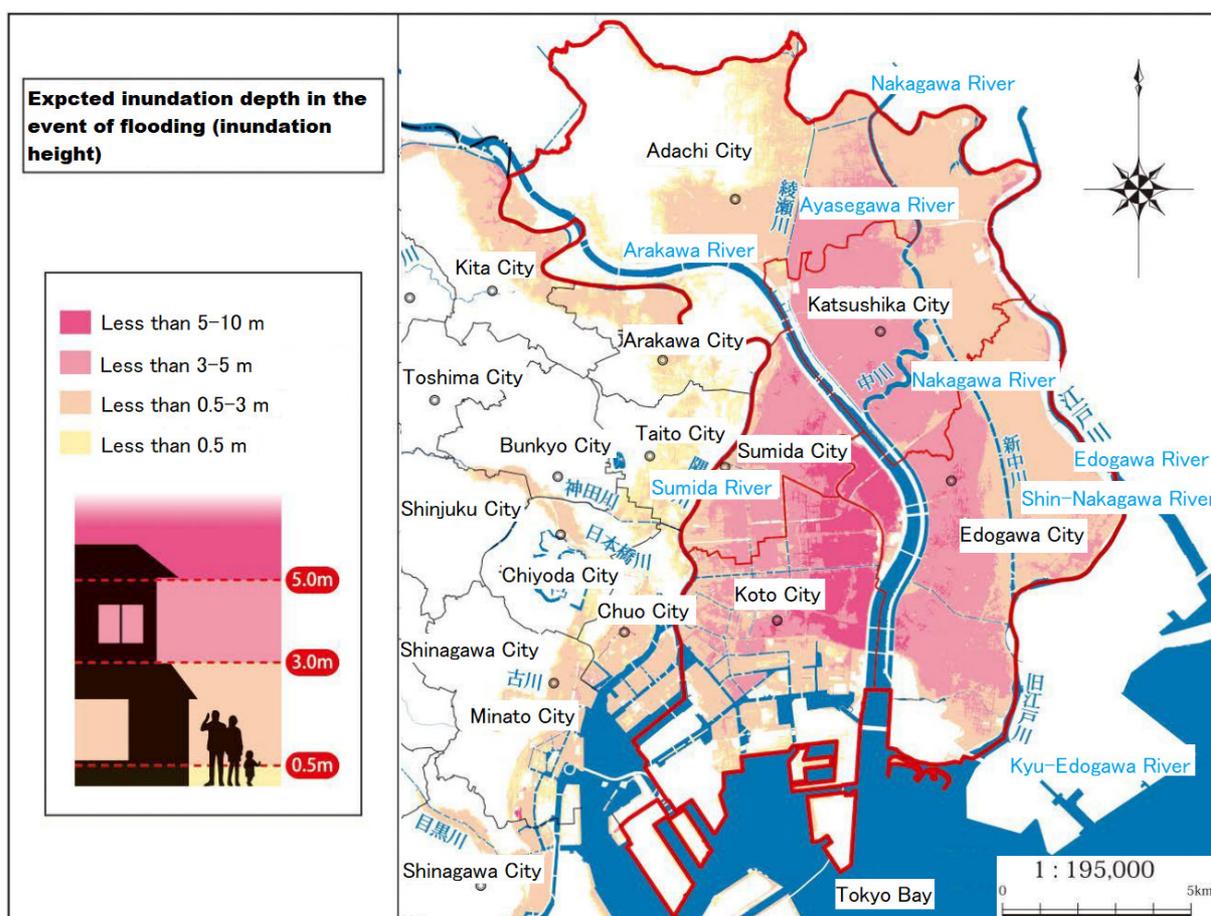
Source: Created by *Discuss Japan* based on data from the Katsushika City http://www.city.katsushika.lg.jp/_res/projects/default_project/_page_/001/018/693/hmbig3-4.pdf

Discharges into a large river through multiple upstream basins prevented the Nakagawa and Ayase rivers from overflowing after Typhoon Hagibis made landfall. According to the Edogawa River Office of the Ministry of Land, Infrastructure and Transport (MLIT), the Metropolitan Area Outer Underground Discharge Channel and the Misato basin helped reduce the water level of the Nakagawa River by 30 centimeters and reduced the time spent above the dangerous water level by 23 hours. In addition, the Ayase River Basin helped reduce the water level of the Ayase River by 78 centimeters and reduce the time spent over the flood dangerous water level by 24 hours. Without these facilities, the Ayase River would also have gone over the planned high water level (see Figure).

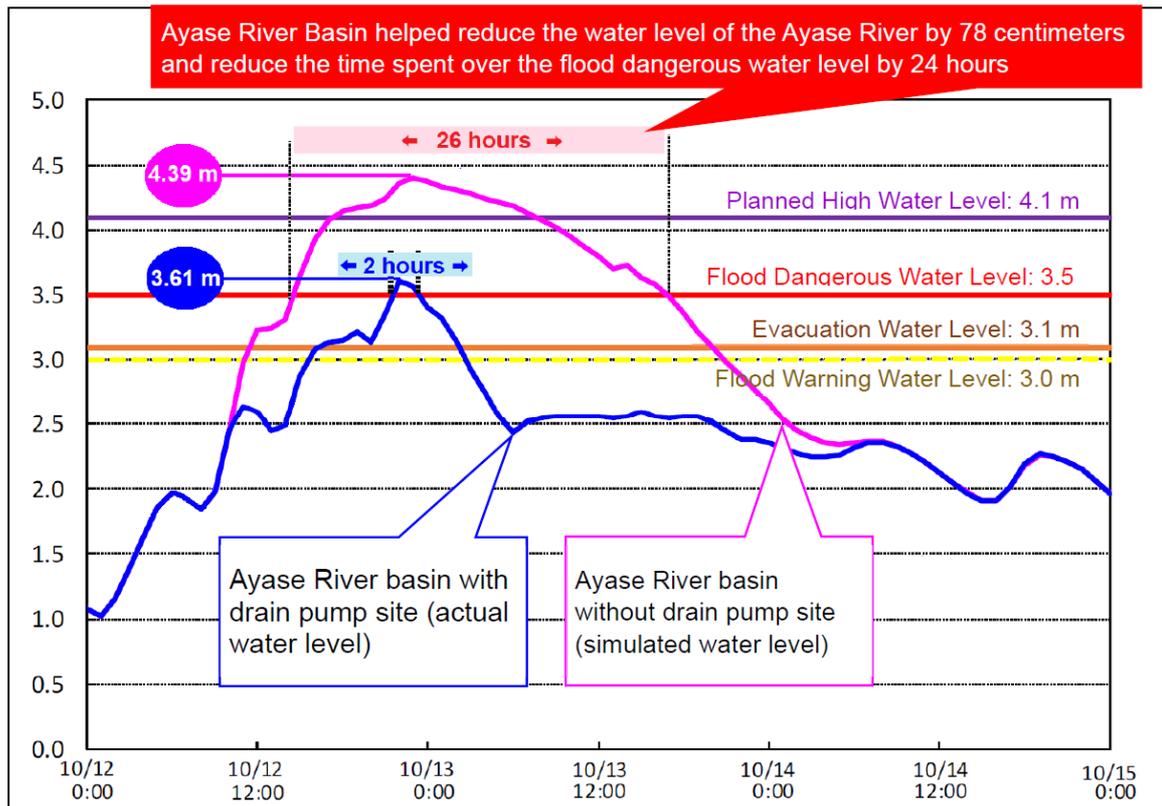
The Ayase River saw its water level reduced significantly by discharges through the discharge channels and a drainage pumping station

Note: Ayase River (observed at the Yako Water Level Observation Station)

Chibana Takeyoshi, an associate professor at the Graduate School of Engineering of the University of Tokyo, notes how effectively the discharge channels (and basins) worked, saying, “The reduction of the time spent over the dangerous water level led to an alleviation of the danger of a crisis and the shortening of the time period when people needed to be cautious of the typhoon, which resulted in the lifting of an evacuation advisory more quickly.”

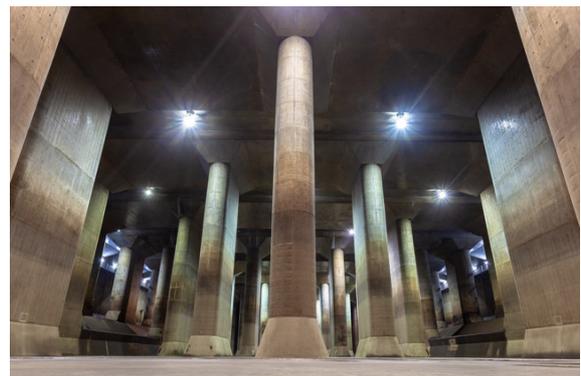
The Metropolitan Area Outer Underground Discharge Channel discharged a volume of water nine times larger than the Tokyo Dome through its underground spaces.

Called the Underground Palace, the Metropolitan Area Outer Underground Discharge Channel in Kasukabe City in Saitama Prefecture is one of the world’s largest discharge channels, completed in 2006 at a cost of about 230 billion yen. It discharges water from five rivers, including the Nakagawa River, through a 6.3 km discharge channel 50 meters below ground.

The Metropolitan Area Outer Underground Discharge Channel began discharging water at 11:30 AM on October 12 and discharged about 115 billion cubic meters of water (about nine times the volume of the Tokyo Dome) to the Edogawa River by 3:13 PM on October 15, when the discharge pumps finished operating. This was the largest discharge since the heavy rains of Typhoon Etou (Typhoon 18) in 2015, which caused the Kinugawa River to overflow.

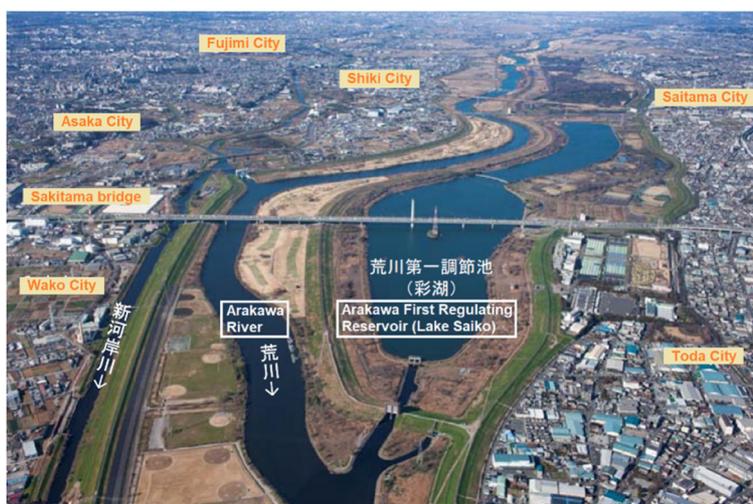
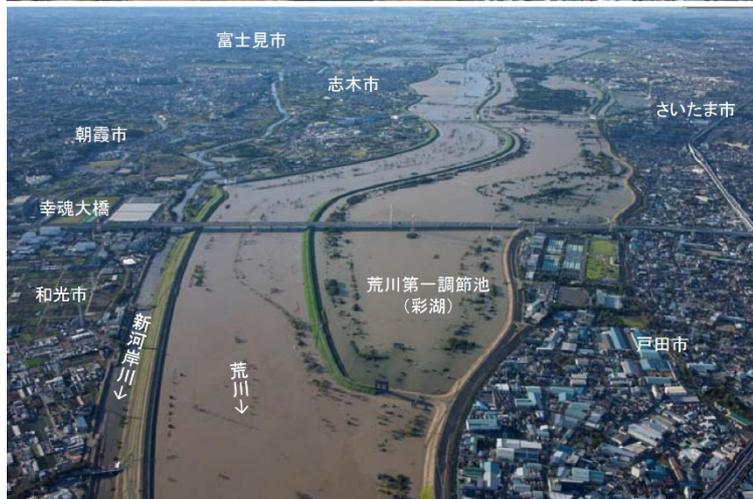
Source: Created by *Discuss Japan* based on the website of the Kanto Regional Development Bureau, Ministry of Land, Infrastructure and Transport https://www.ktr.mlit.go.jp/ktr_content/content/000760776.pdf

The Arakawa First Regulating Reservoir is situated in the middle of the Arakawa River basin and is usually used as a baseball park or a public park. But if the water level of the Arakawa River rises above the overflow bank between the river and

the Regulating Reservoir, the river water will automatically flow into the retention basin. If you close the drainage gate at the exit of the basin, water will collect. Flood control measures using the reservoir were conducted from around 11:35 PM on October 12 to around 10:00 AM on October 13.

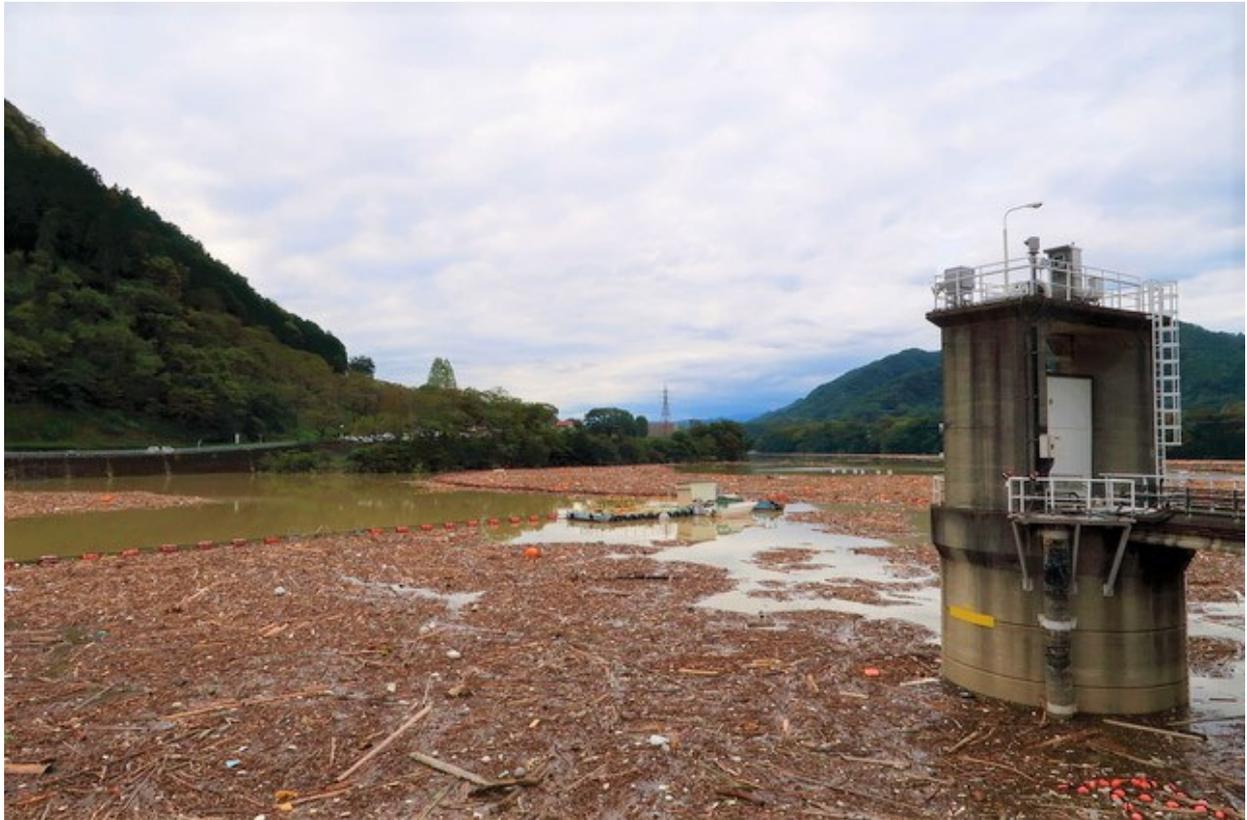
A large amount of driftwood created by Typhoon Hagibis was still floating in the Shiroyama Dam reservoir on 20 October.
